Gustavus PFAS 2019 Site Characterization

GUSTAVUS, ALASKA

Subject: REVISION 1 SUMMARY, GUSTAVUS PFAS 2019 SITE
CHARACTERIZATION, GUSTAVUS, ALASKA

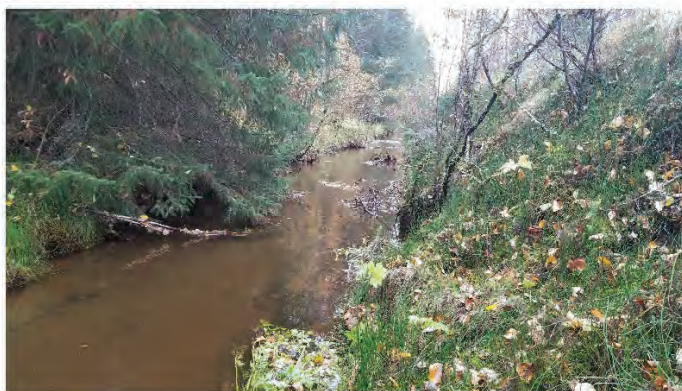
Exhibit 2-1: Example of surface water sample location.

We collected ten surface-water analytical samples during the October 2019 sampling event. Samples were collected from drainage ditches and ponds around and near the airport. These samples were collected with the use of a dust-free, PFAS-free, new disposable clear plastic cups. Cups were submerged approximately 6 inches below the surface of the water body using a freshly gloved hand.

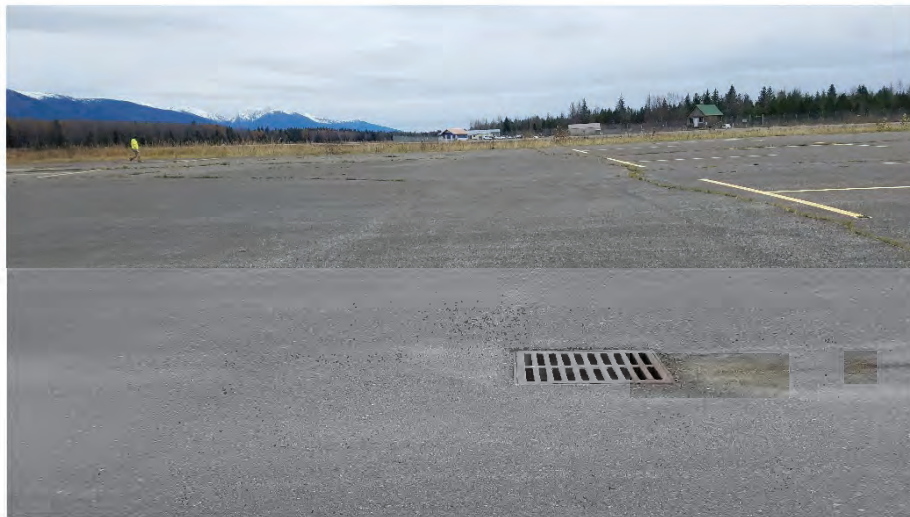
Exhibit 2-3: New fire-training location.

We collected 41 primary surface soil samples and 9 sediment samples between October 10 and October 14, 2019. Surface soil samples were collected along the active runway perimeters and at potential AFFF release locations. Samples were collected in a grid formation from the former fire-training pit. A grid was not possible in the new fire-training location, as most of the area is asphalted, as shown in Exhibit 2-3. We collected surface soil

samples from the edge of asphalt and near the outfall of three culverts directly in the drainage pathway leading from the asphalted area. We collected surface samples using a decontaminated hand trowel to dig to the target depth, then a new, disposable stainless-steel spoon to fill the laboratory-provided sample jars.

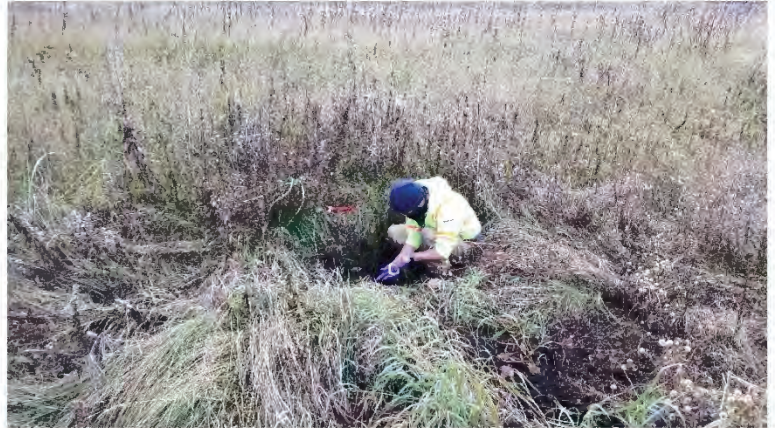
Exhibit 3-1: Collecting surface soil sample near *Culvert 2*.

We also collected surface-soil samples from culverts and drainage outfalls in the direct drainage pathway from the "new" fire training area (locations *SS-19-30* through *SS-19-32* and *Culvert-1* through *Culvert-3*). Each of these locations exceeded the PFOS MTGW cleanup level by twenty times or greater. The outfall samples also exceed PFOA MTGW for samples *SS-19-30*, *SS-19-31*, *Culvert 1* and *Culvert 3*.

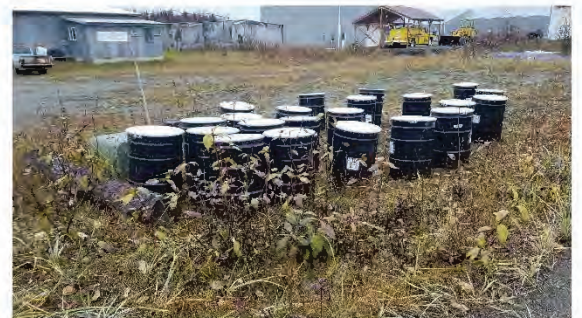
Exhibit 3-2: Soil IDW storage drums.

We collected analytical samples from each 55-gallon drum containing soil derived from investigation activities. None of the analytical results were above DEC cleanup levels; however, the drums do contain soil from locations where the analytical results exceed DEC cleanup levels.

Additionally, Drum 15 contains the spent GAC used for filtrating purged groundwater. A separate letter report will be submitted to DOT&PF and DEC presenting the analytical results and discussing disposal options. The drums will be disposed of accordingly, following DEC approval. DEC approval will be obtained prior to moving or disposing of the soil drums using the DEC Transport, Treatment, and Disposal form.
